September 27, 1996

IHSS 118.1 - CARBON TETRACHLORIDE SPILL SITE (KH00003NS1A) - JEL-207-96

IHSS 118.1 CARBON TETRACHLORIDE SPILL SITE

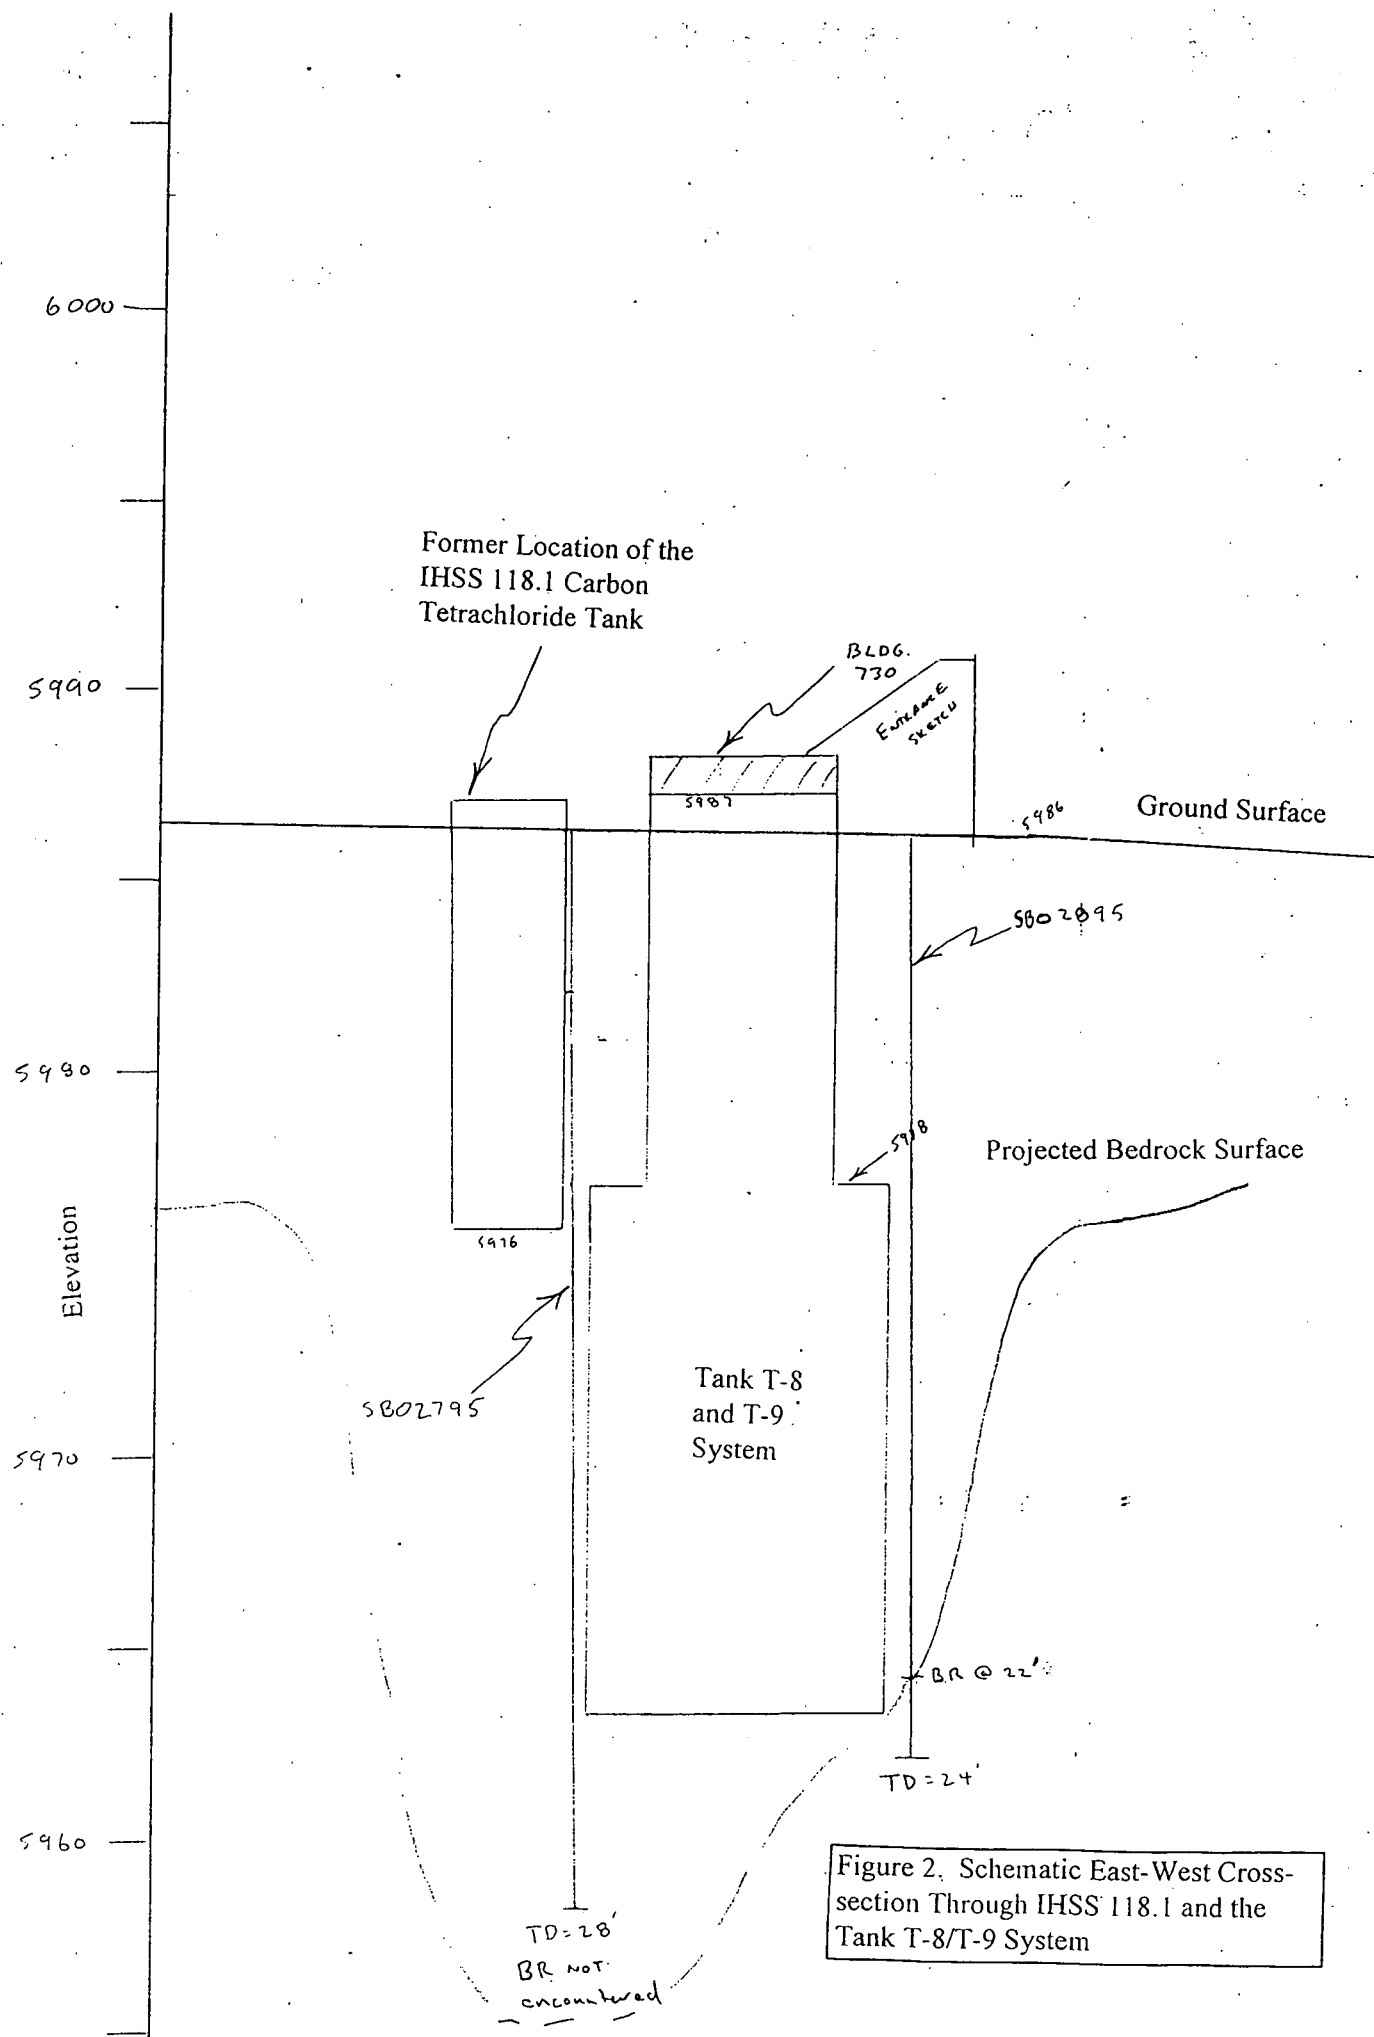
Figure 2. Schematic East-West Cross-section Through IHSS 118.1 and the Tank T-8/T-9 System

The excavation for the Tank Systems was completed in 1955; prior to installation of the carbon tetrachloride tank in 1977. The excavation is deeper and immediately east of the former location of the carbon tetrachloride underground storage tank (Figure 1). The east-west cross section for this area (Figure 2) shows the relative position of these tanks.

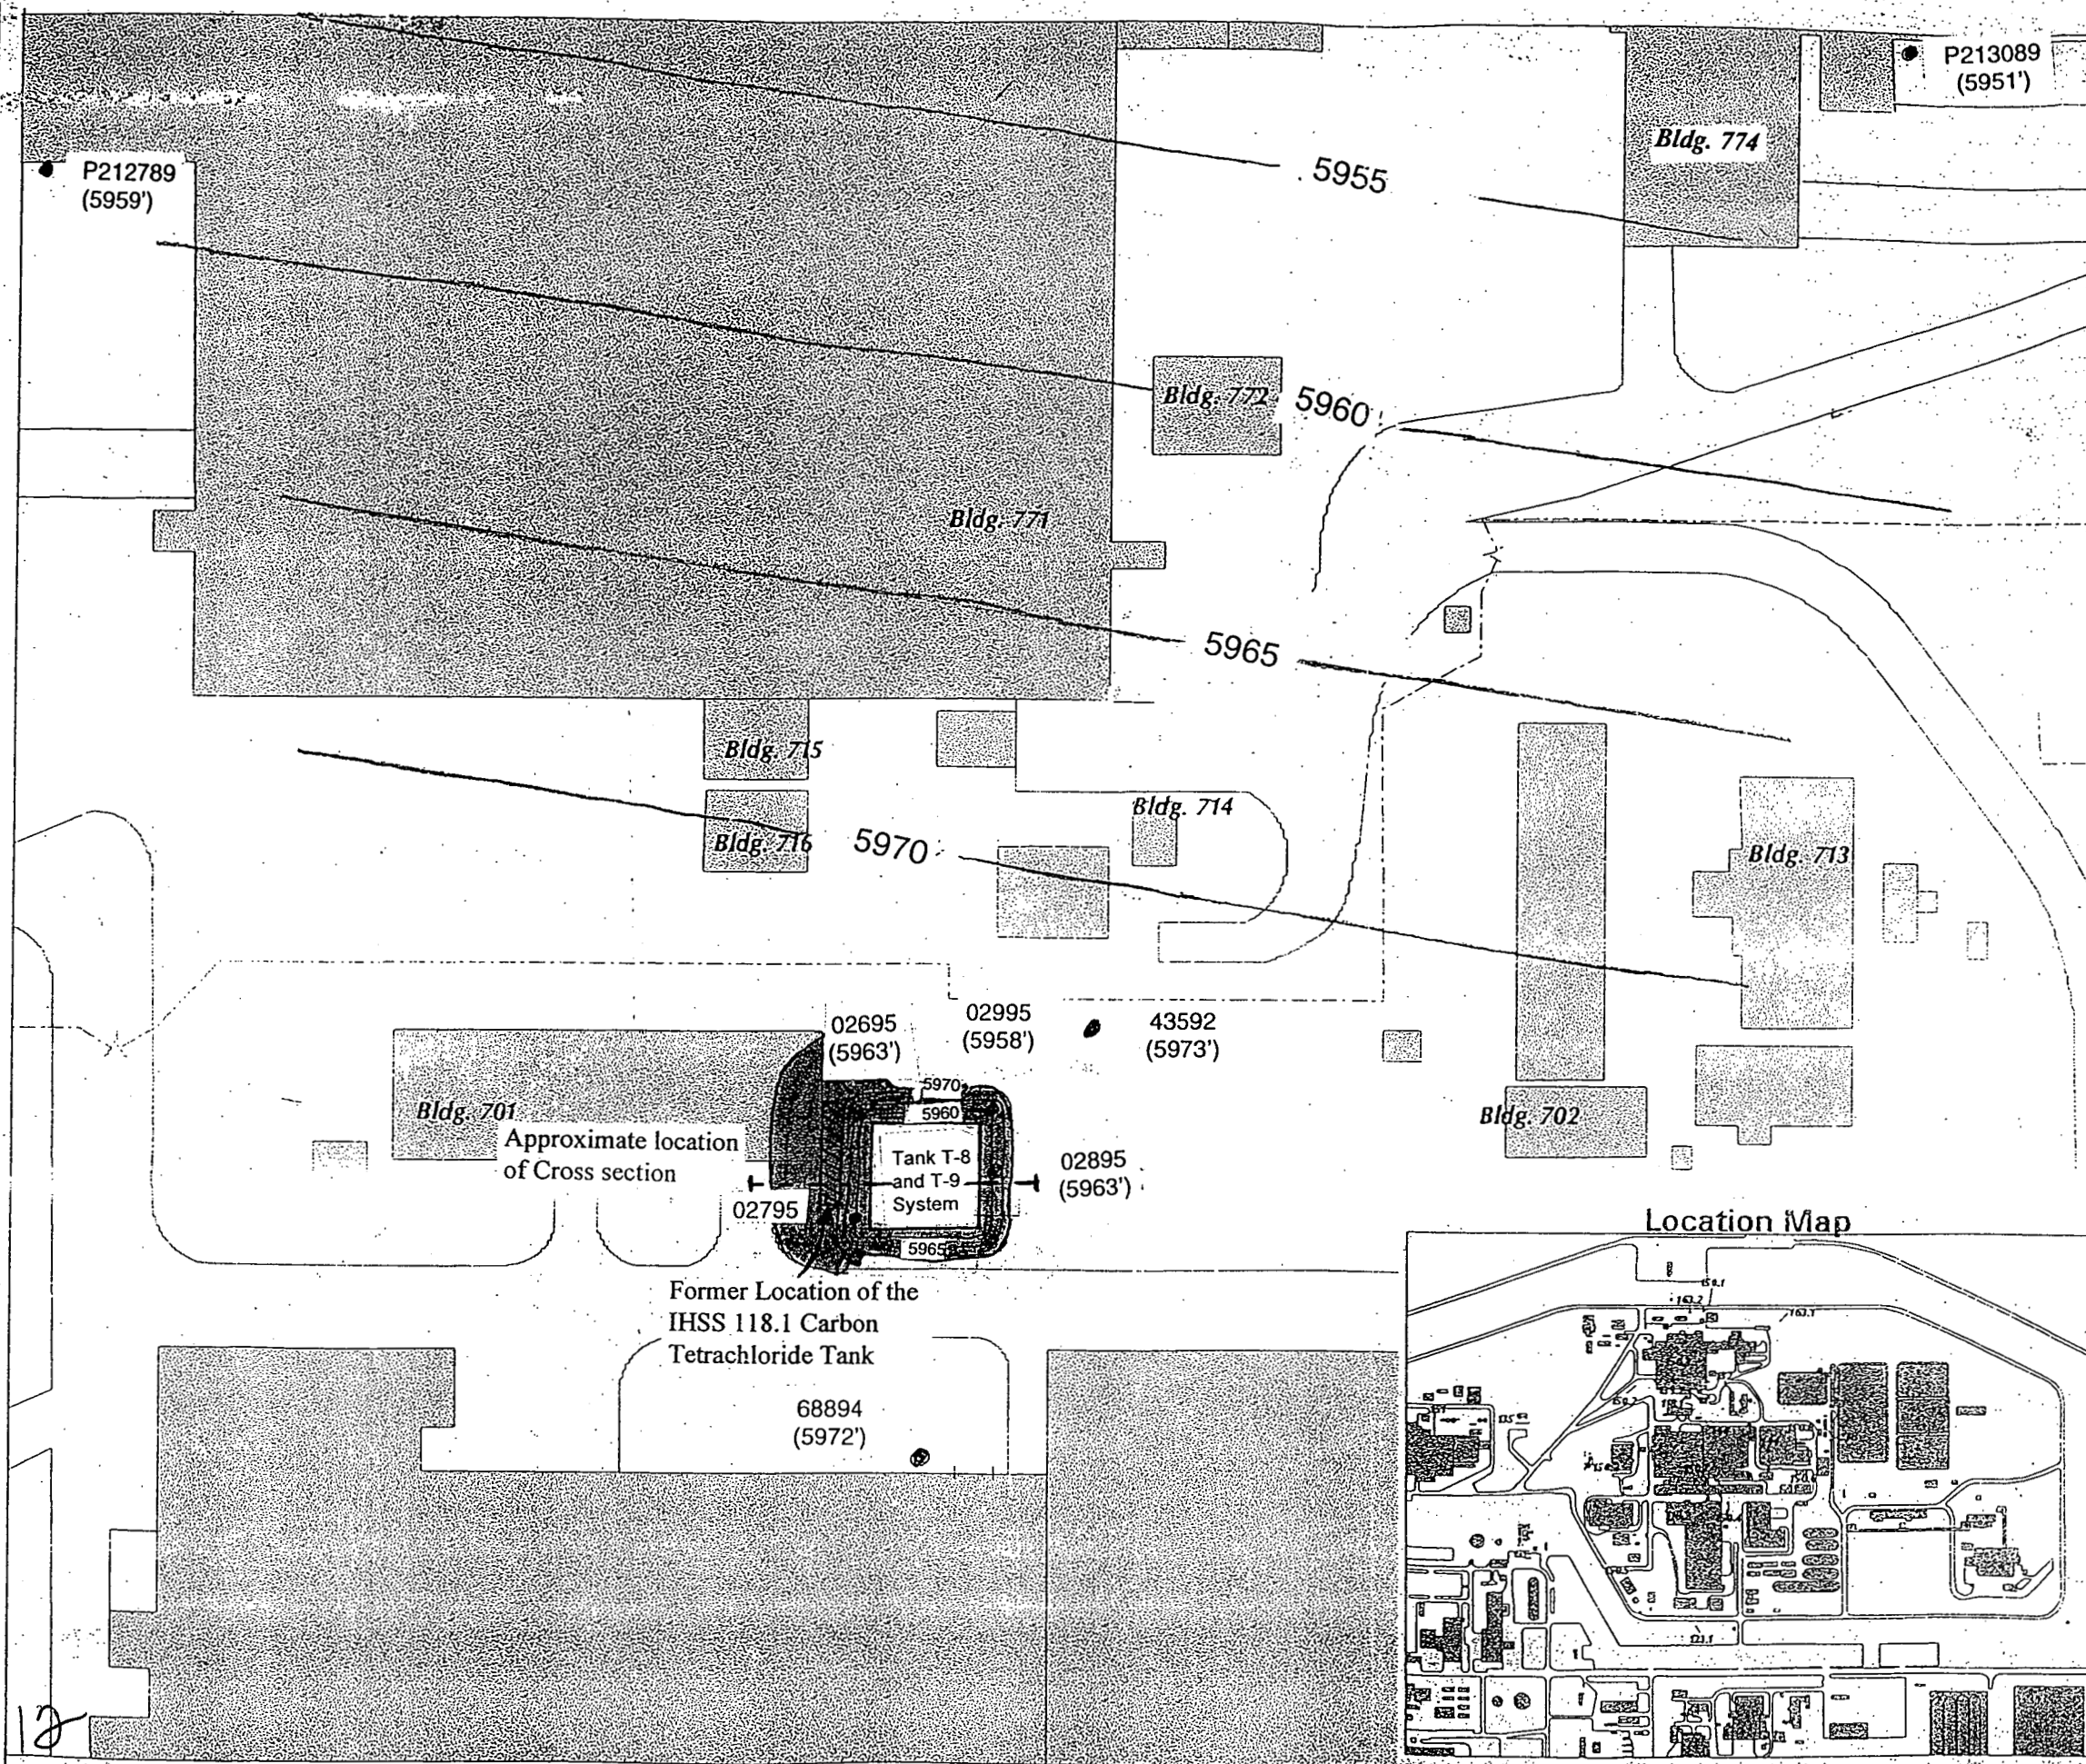
Very few data points are available to determine the present configuration of the bedrock surface. However, a bedrock surface contour map of this area using all available data is shown on Figure 1. It appears that the excavation for the Tank Systems is the dominant bedrock surface feature in the area. It is assumed that the construction to install the Tank Systems excavated as little material as was necessary to meet the requirements of safety and to minimize costs and waste. This probably resulted in a minimally sloped, steep-sided excavation 10 to 25 feet wider than the Tank Systems, with a bedrock surface approximately 10 to 20 feet deeper than the surrounding area.

Most of the carbon tetrachloride resulting from surface spills and leakage from the underground storage tank is expected to have migrated downward into the excavation surrounding the Tank Systems. If sufficient material was spilled to completely fill this excavation, the excess material is expected to flow eastward possibly along the process waste line excavation, and also toward Buildings 771 and 774. Based on existing borehole data, Figure 1 depicts the minimal expected extent of free product in this area. Figure 3 depicts the maximum extent of free product in the vicinity of IHSS 118.1. Differences between these maps are based on the amount of carbon tetrachloride spilled.

The minimum expected extent is based on the assumed size and location of the excavation for the Tank System, and the behavior of carbon tetrachloride in the subsurface. Depending on the size of the excavation, and the volume of material spilled, there is a possibility that carbon tetrachloride has overtopped this excavation and spread out as a much larger contaminant plume to the north and south. The extent of the free product would be controlled by bedrock structures, utility corridors and variations within the fill and alluvium.

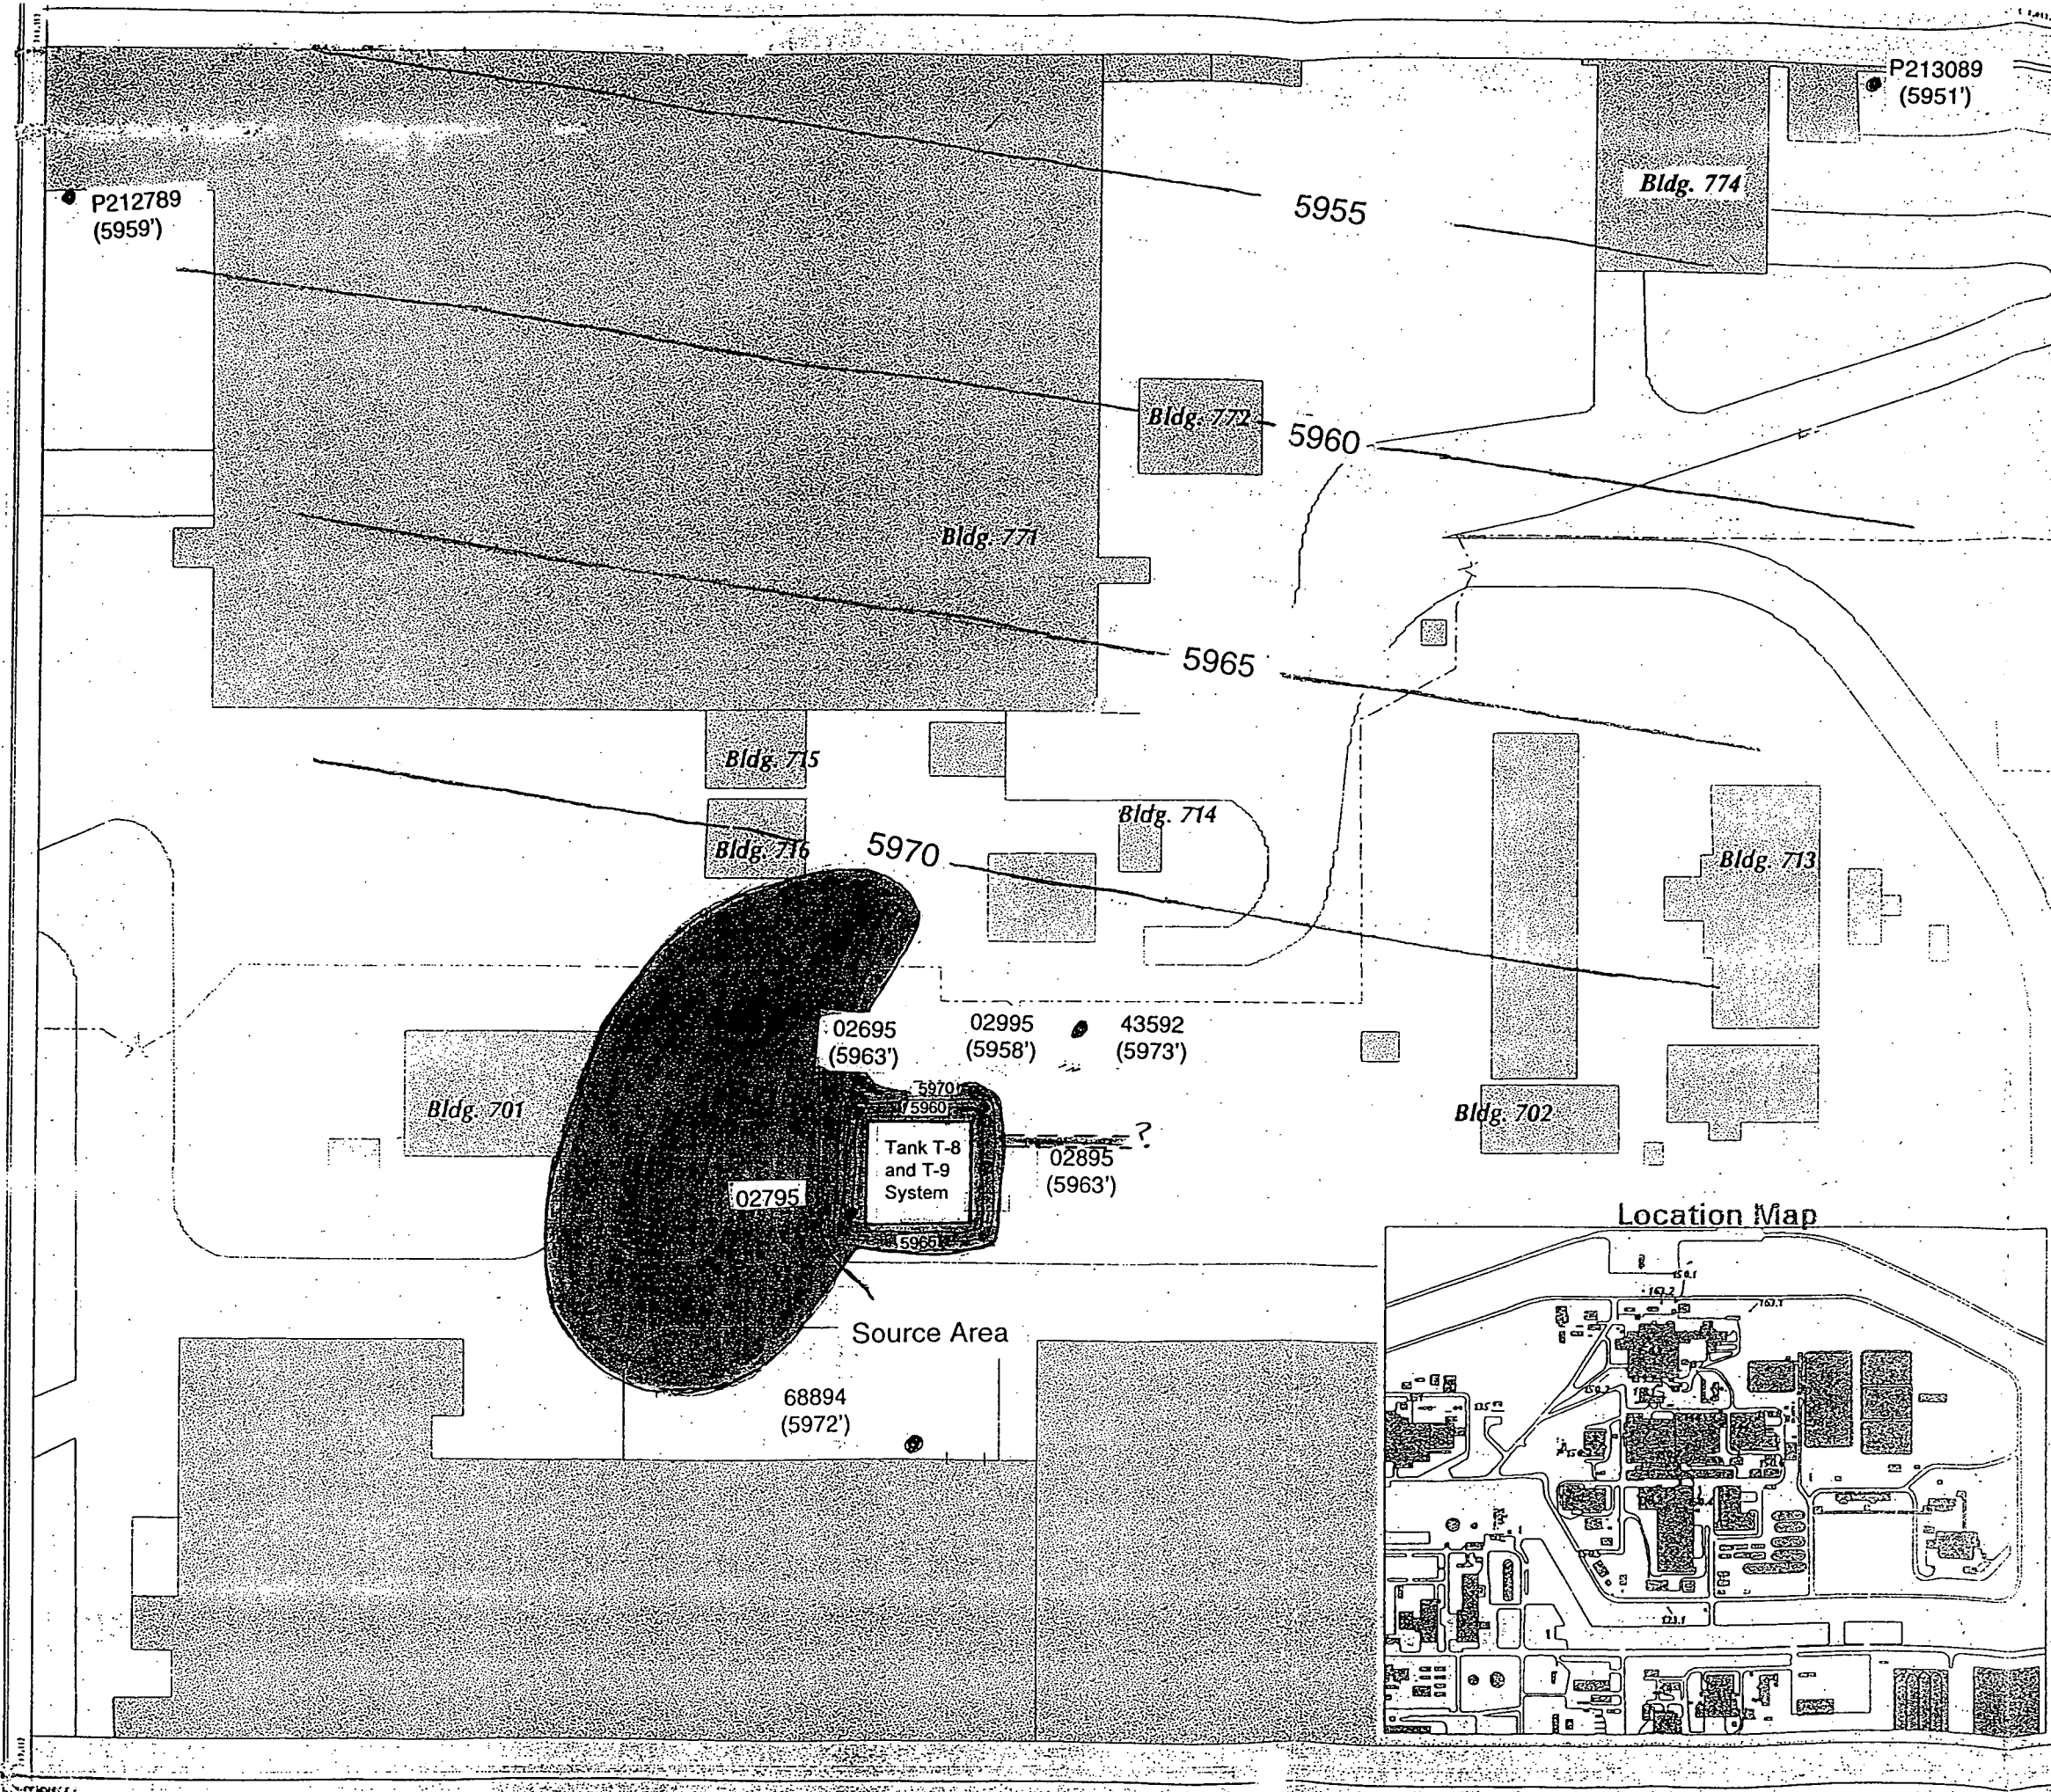
Figure 3

material would most likely have ended up within the closed bedrock low caused by excavation for the Tank Systems. If sufficient carbon tetrachloride was released to fill up this bedrock depression, then the additional carbon tetrachloride would be expected to flow towards Buildings 771 and 774 along the bedrock surface created during construction of these buildings (Figure 3). Lateral movement of the carbon tetrachloride to the north is expected to be controlled by the south walls of the buildings, and the contaminant may be slowly removed by seepage into the buildings' footing drain systems.
